Township of Muskoka Lakes

Burgess Dam Class EA

Project File Report (PFR)

TULLOCH Document No. / Rev. 20-1051-20-2050-0003 / Rev. 1

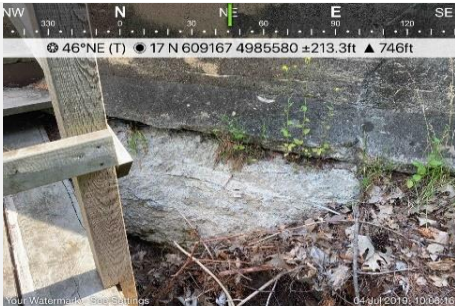
View of downstream dam face, note concrete degradation on cold joint

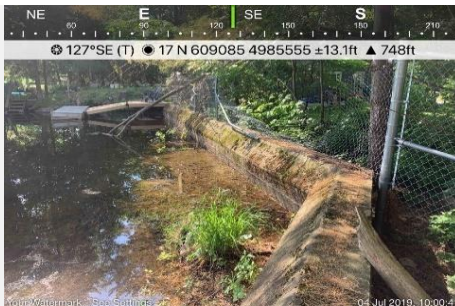
View of upstream face, note broken fence and vegetation build up along downstream toe of dam

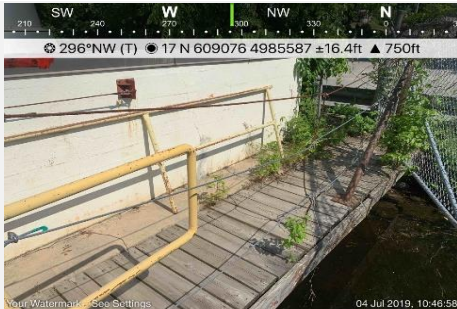
North abutment of dam, concrete ends at guard rail at embankment of Riiver Street, good contact observed

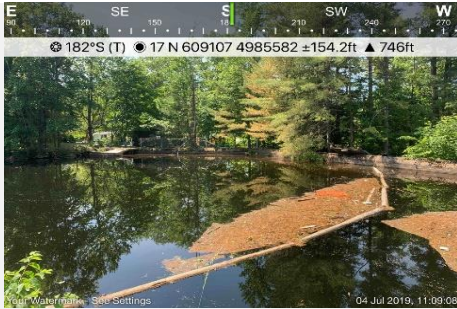
Upstream pond note ~0.7m of free board at time of site visit

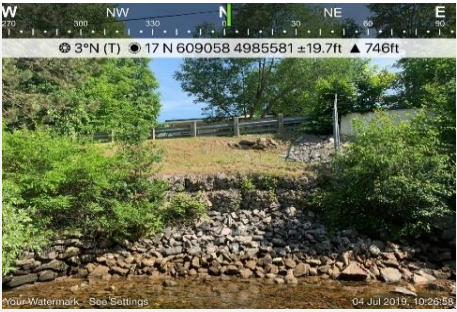
The embankment north of the dam and located west of the powerhouse is eroded and very steep, washout in 2019 observed at toe of concrete retaining wall. Rock fill was placed back in the area of the washout by the township

Steep embankment on north side of dam, photo taken downstream at tailrace note retaining wall

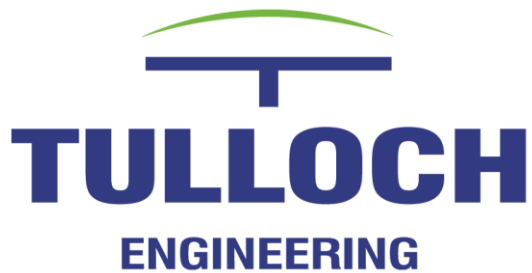
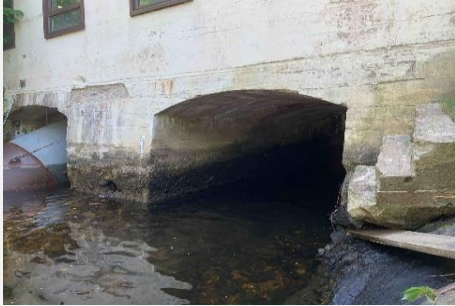
Large crack through retaining wall, note movement of wall

Large transverse crack running through powerhouse foundation, hole in wall at outlet of power house with significant seepage of ~ 2.0 L/s, possible outlet of historic box drain

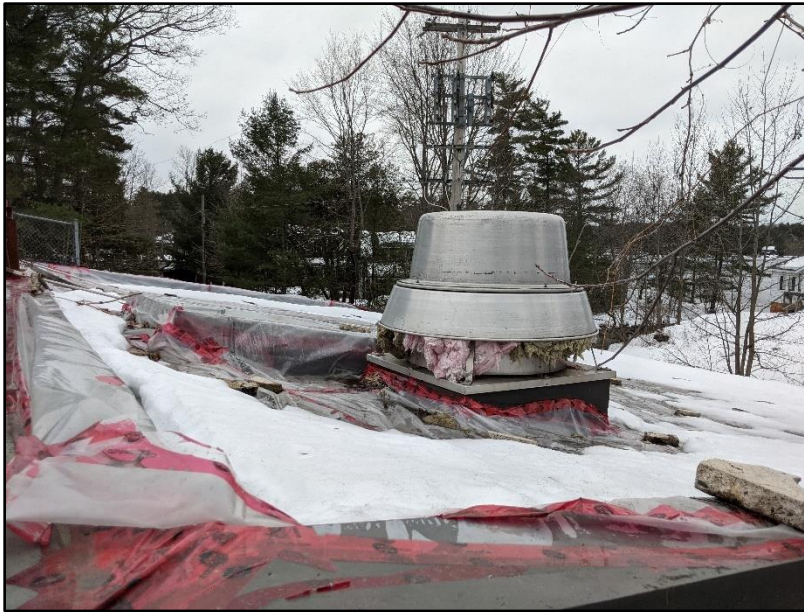
Figure 4: Unfinished Roof Surface

The roof is partially unfinished and covered in construction polypropylene sheets to maintain the moisture barrier. Snow loads and heavy rainfalls could have significant impact on the structure if not properly maintained and inspected on a regular basis.

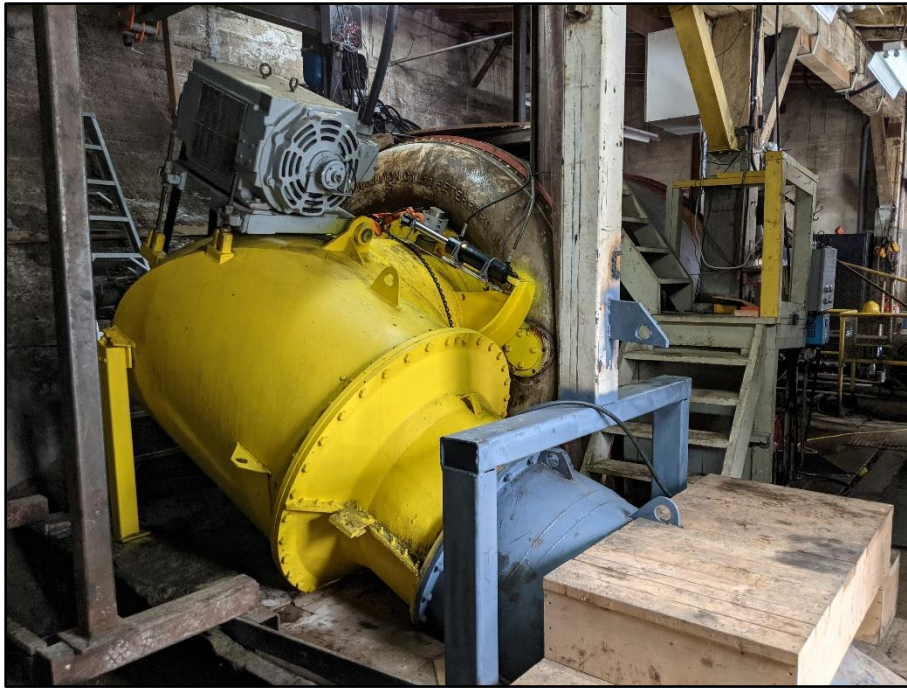
Figure 6: Recent Machine Modification (Left-Hand Side)

A recent modification to the machine on the left-hand side (looking upstream) was completed where a new turbine has been retrofitted to one side of the pressure case. Limited information is available, but the turbine appears to be an inclined propeller turbine operating with the original belt driven generator

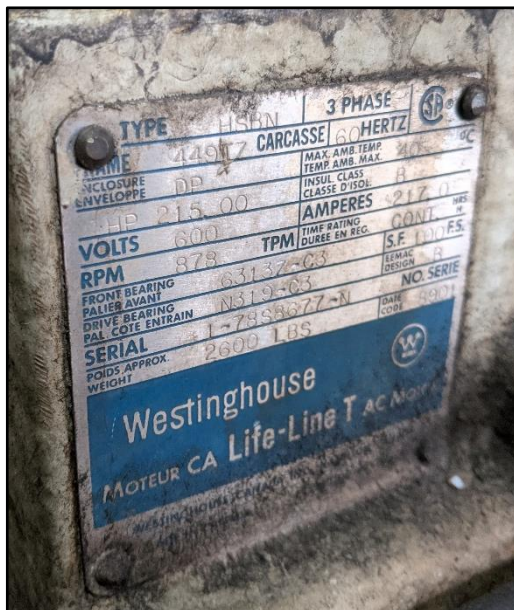
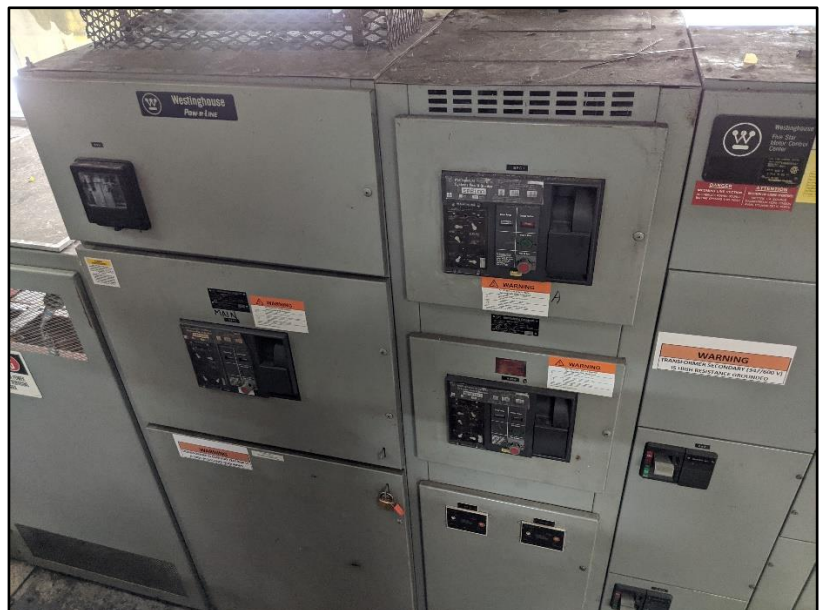
Figure 7: Generator Nameplate and Electrical Cabinet

The generators and electrical system are assumed to be original and in fair condition, but should be cleaned to remove dirt and debris. Since the units were not in operation, no further observations could be made.

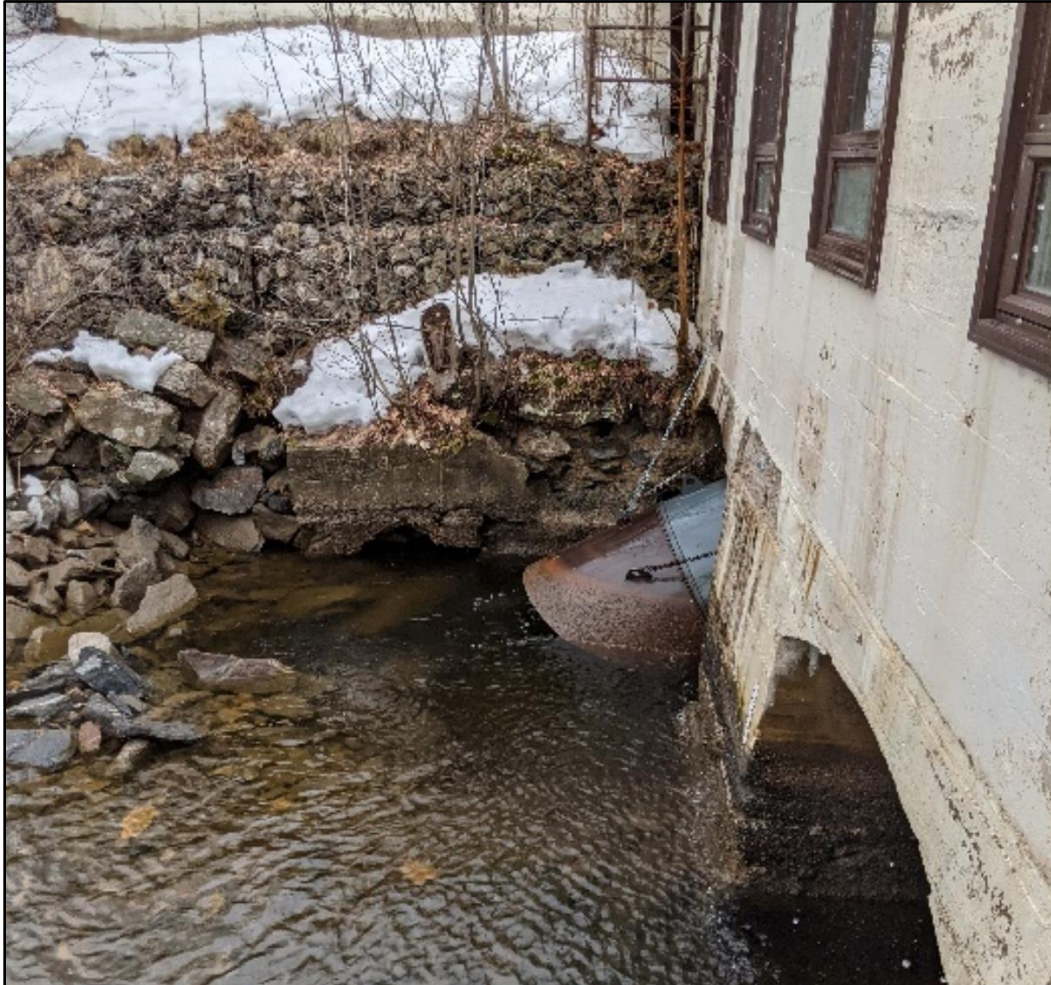
Figure 8: Draft Tube and Discharge Area

The draft tube and discharge area were not accessible, other than visually from near the bay door entrance to the station. The outlet of the draft tube of the modified turbine is obstructed by rocks from the nearby wall embankment. No visible observations were able to be made on the other machine's draft tube, which is assumed to be vertically conical in design.

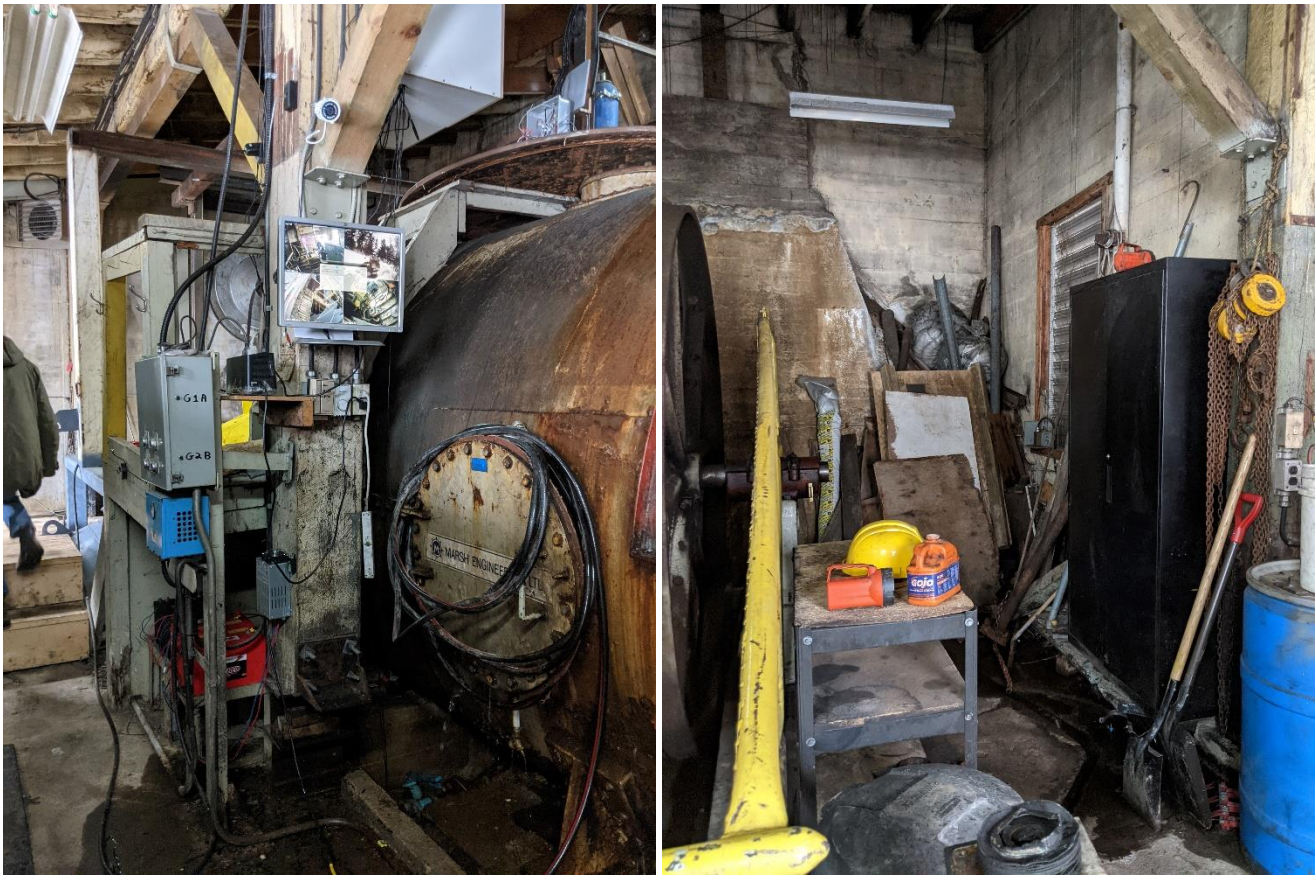
Figure 9: Station Cleanliness and Concrete Degradation/Oil Saturation

Improvements to the station's general cleanliness and organization would be beneficial. Dirt and grime are prevalent throughout the station and coat much of the stationary equipment. Sections of the concrete in the floor and walls have been cracked and broken or appear oil-stained and should be maintained consistently.

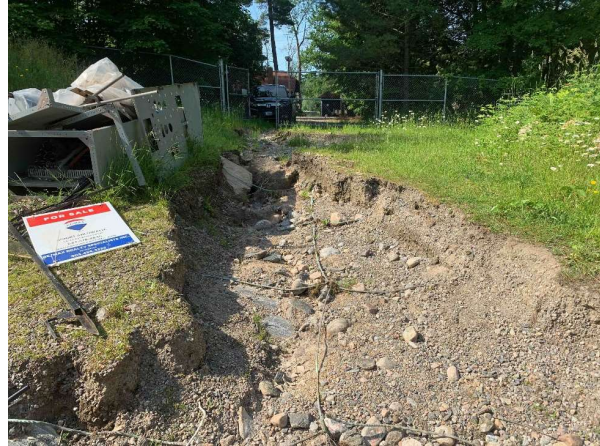
I'd like to now take some time to discuss the events of Spring 2019. As perhaps many of you may recall there was historic flooding along the Muskoka watershed last year. The flooding was largely attributed to a large snow accumulation accompanied with a rapid melt due to a sudden temperature increase and heavy rains during the spring melt. These conditions along with the cascading nature of the Muskoka Watershed led to very high water levels and flooding that was experienced throughout the region. As a consequence of this flooding Burgess 1 Dam experienced an overtopping event. Based on descriptions from eye witnesses water levels were approximately 0.3 – 0.4m above the current crest of the dam and caused considerable washout of the property as pictured to the right.
