Township of Muskoka Lakes

Burgess Dam Class EA

Project File Report (PFR)

TULLOCH Document No. / Rev. 20-1051-20-2050-0003 / Rev. 1

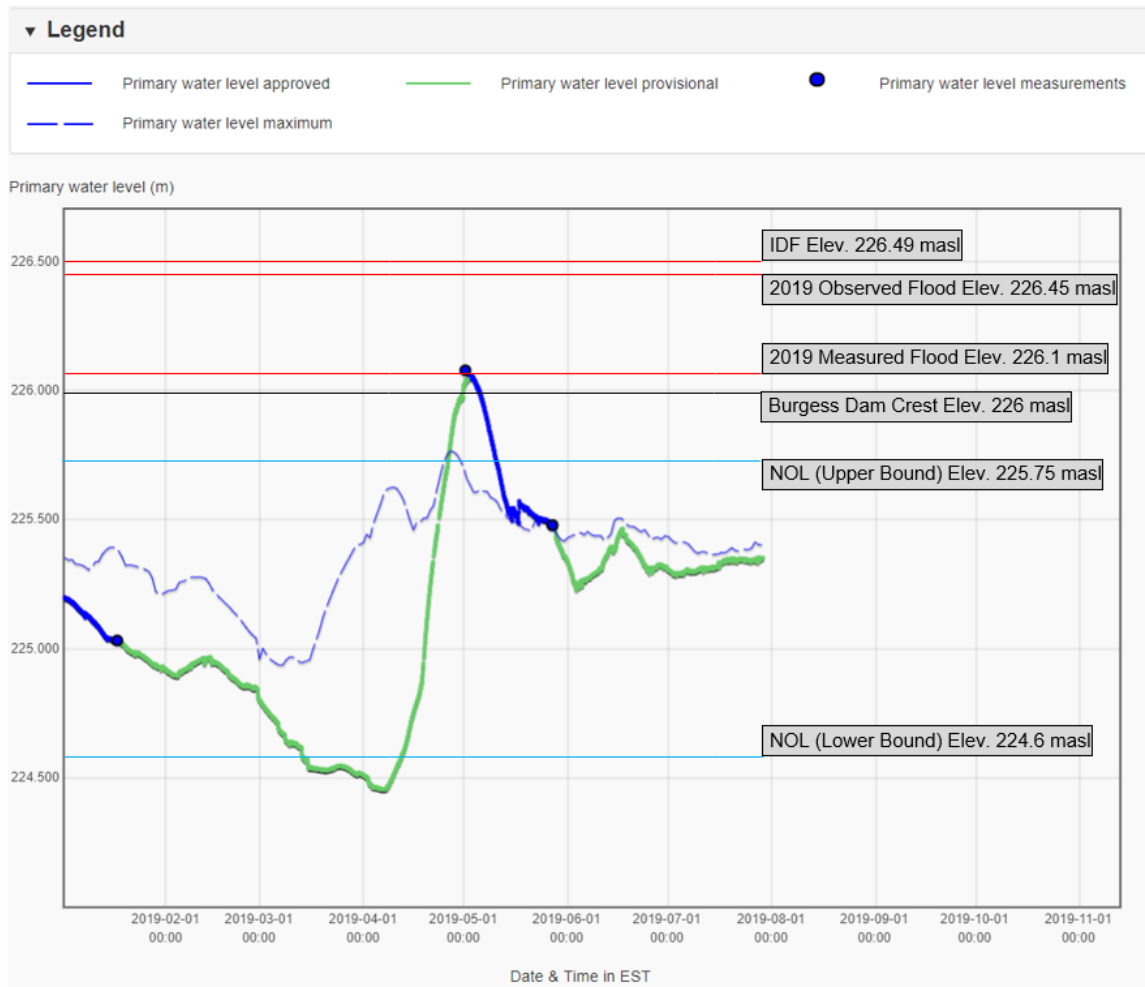
Figure 7-1: Burgess Dam 1 - 2019 Water Levels vs. NOL and IDF

- The facility has no spill capacity as upstream water level control is provided by the Bala North and South Falls Dams. Based on their proximity and virtually parallel positioning along the watershed it has been determined that the design IDF for the Bala South and North Dams is the most appropriate value for use at the Burgess 1 Dam location.

- The existing Burgess 1 Dam crest is at El. 226 m. During the determined IDF event water levels are above the dam crest by 0.39 m. Therefore, it can be determined that the Burgess dam does not have sufficient freeboard nor was the existing facility designed to handle IDF in its current state.

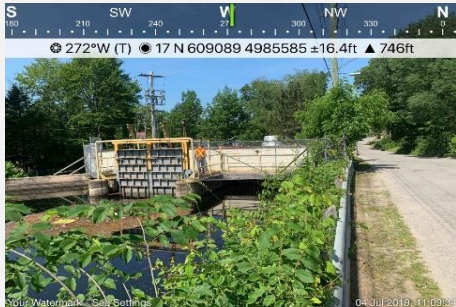
View of pond and sluiceway, note road embankment on pond, insufficient erosion protection

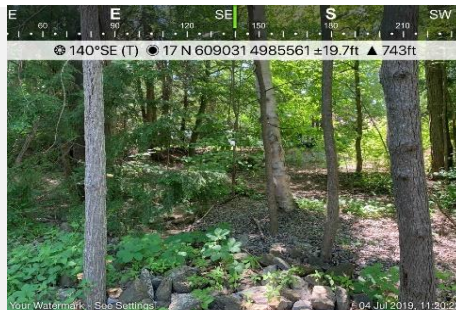
Area of washout where water was spilling over the dam and down to tail race, site of temporary ditch excavated to channel water away from properties

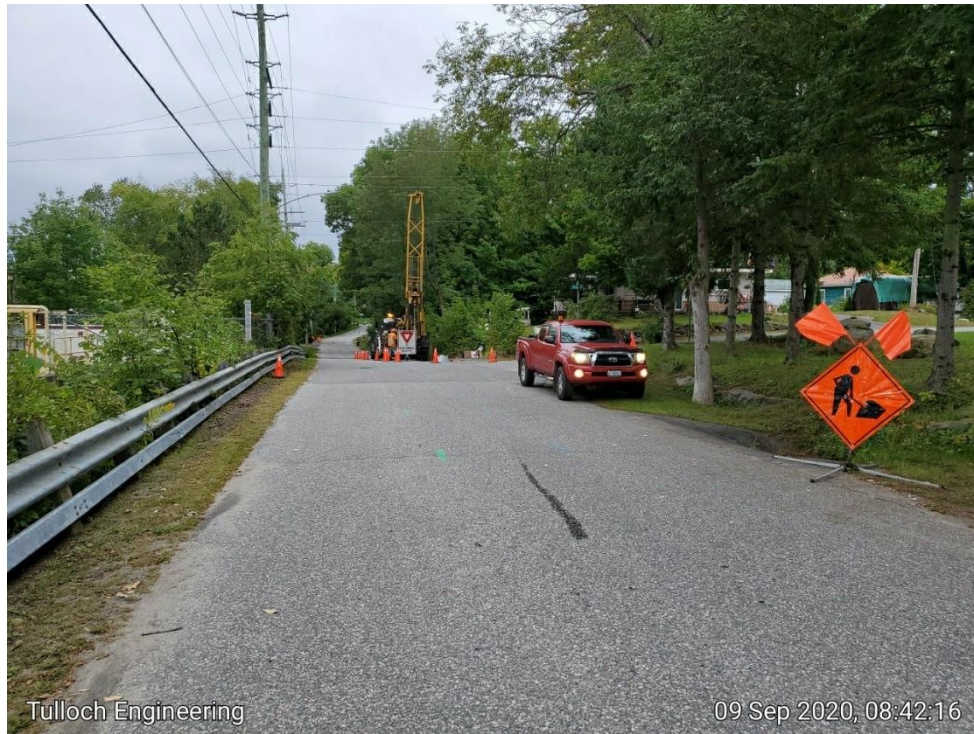
Photo 1: General investigation area, note low powerlines on left side of photo which prevented drilling closer to the North Slope. Powerhouse on left.

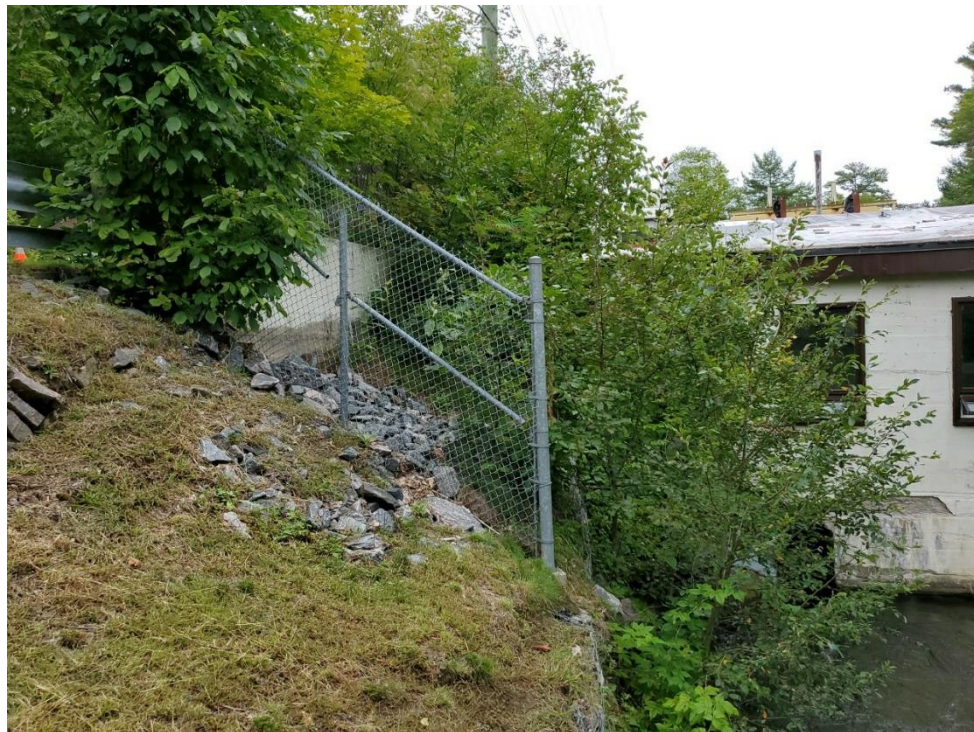
Photo 2: Retaining wall near road surface, gabion basket wall at slope toe. Powerhouse on right. Image looking from downstream of powerhouse to upstream.

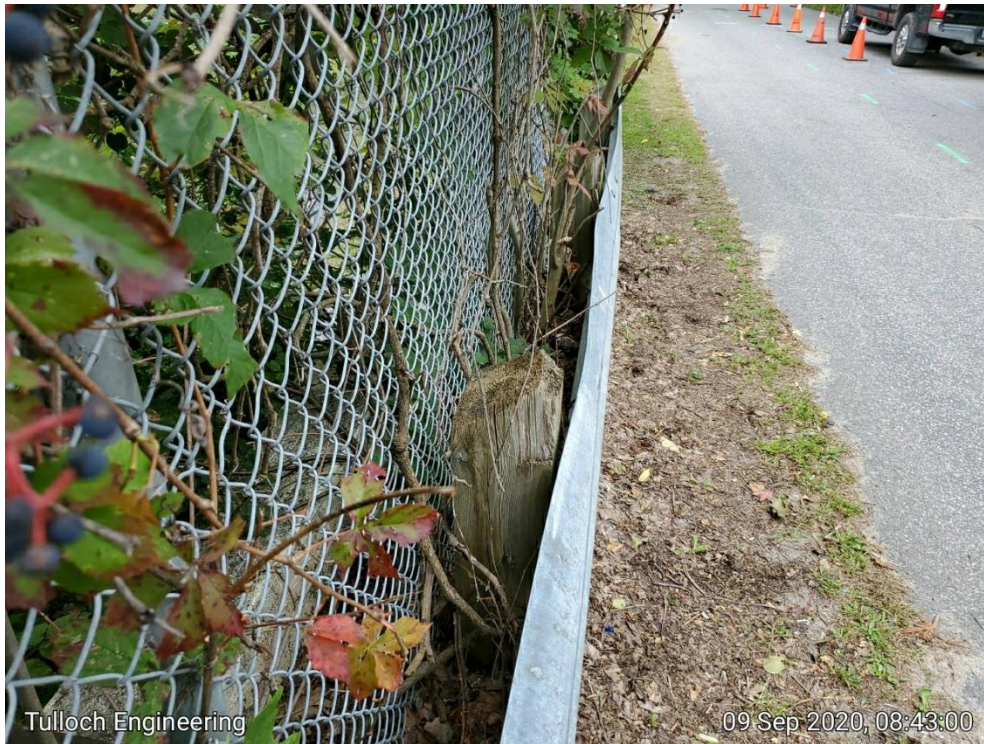
Photo 3: View of retaining wall behind the fence from road surface.

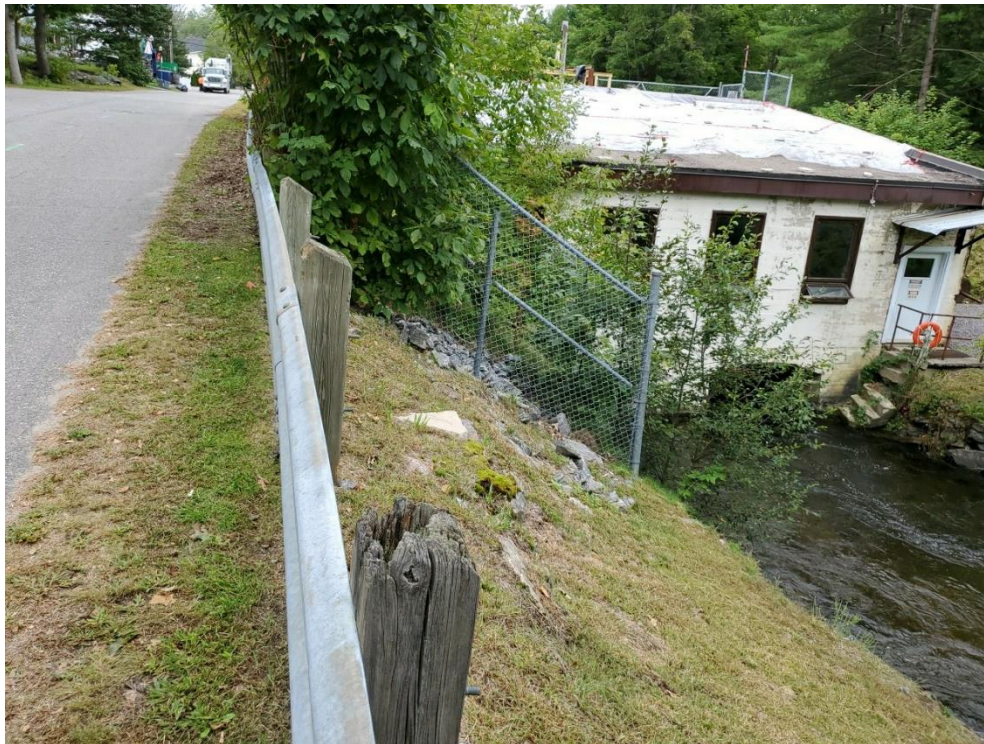
Photo 4: North Slope with powerhouse and tailrace in background on right. Note abrupt slope change where gabion basket wall exists at break in slope.

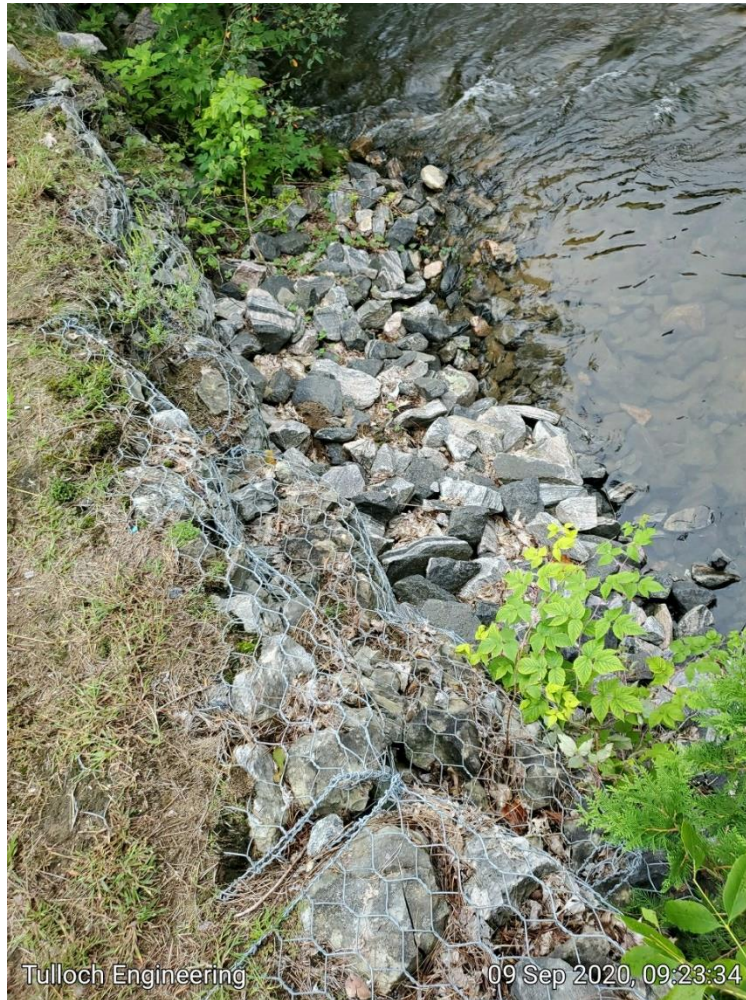
Photo 5: Gabion wall at toe of North Slope. Note rockfill located at toe of gabion wall above tailrace water level.
